Our Lady of Dolours

**Proposal
for the Repair and Renovation
of the Parish Presbytery**

June 2021

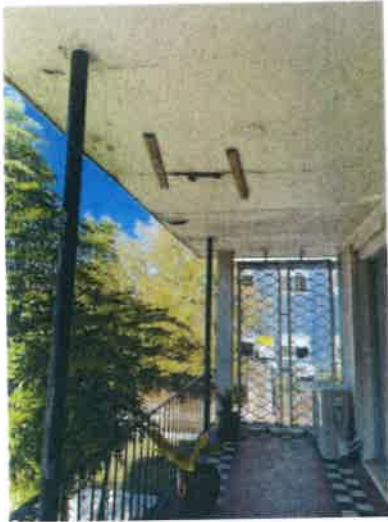
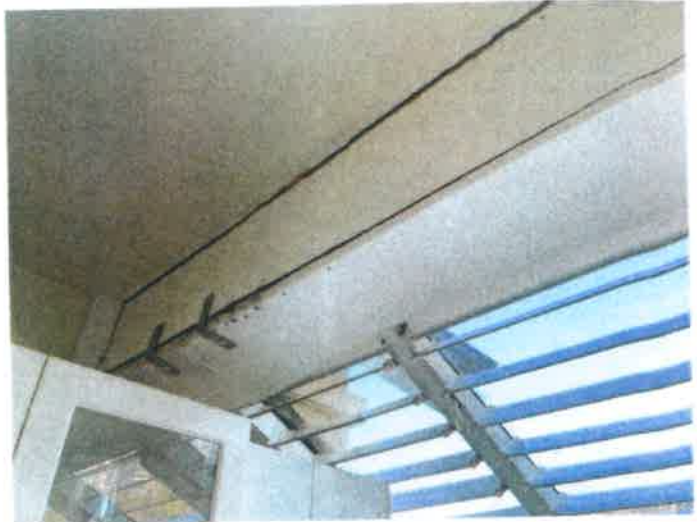
Several Significant Repairs

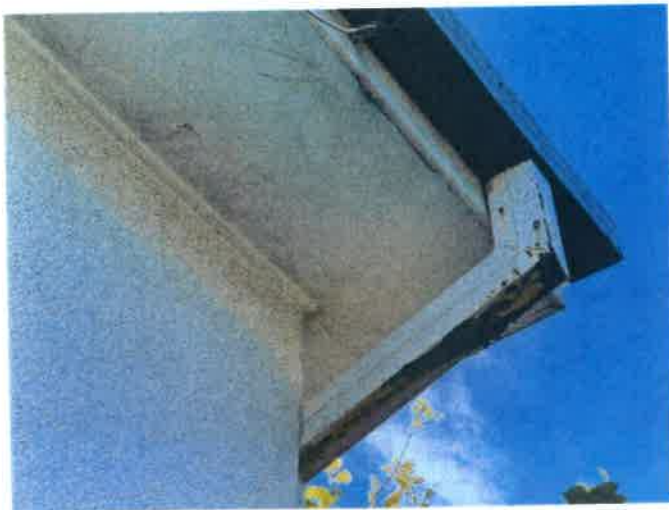
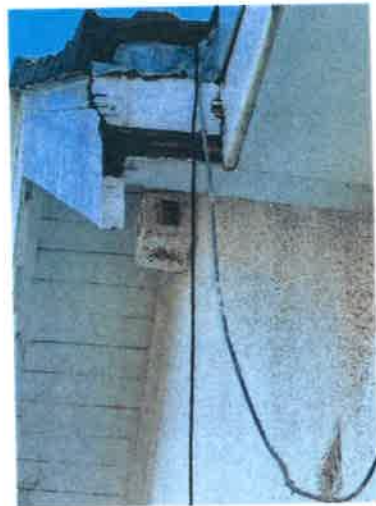
Replacement of guttering and eaves and fascias

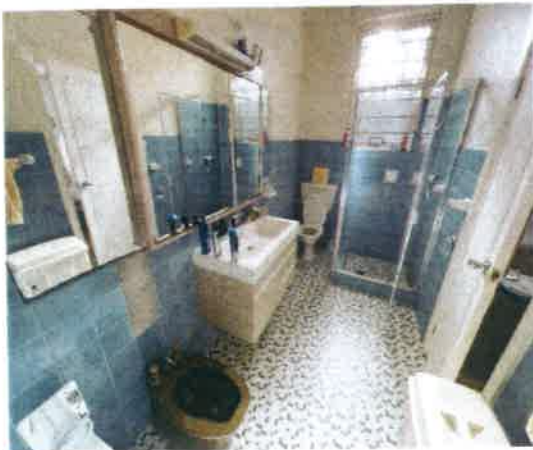
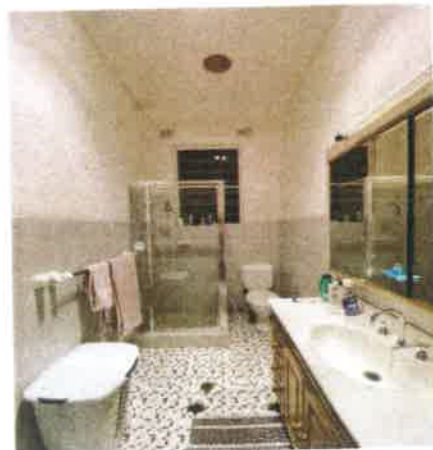
The re-fitting of two bathrooms to replace existing aged ones

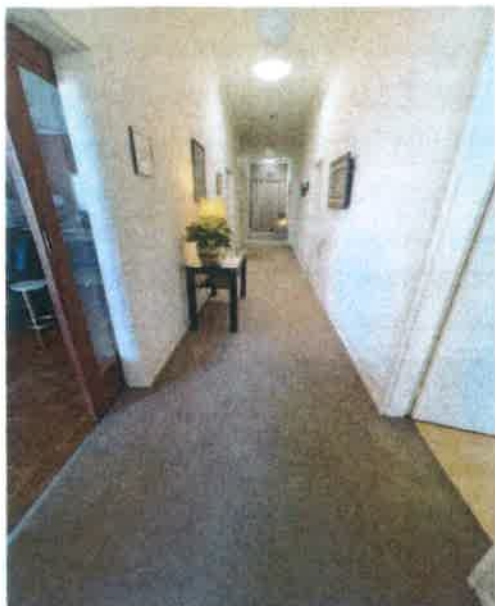
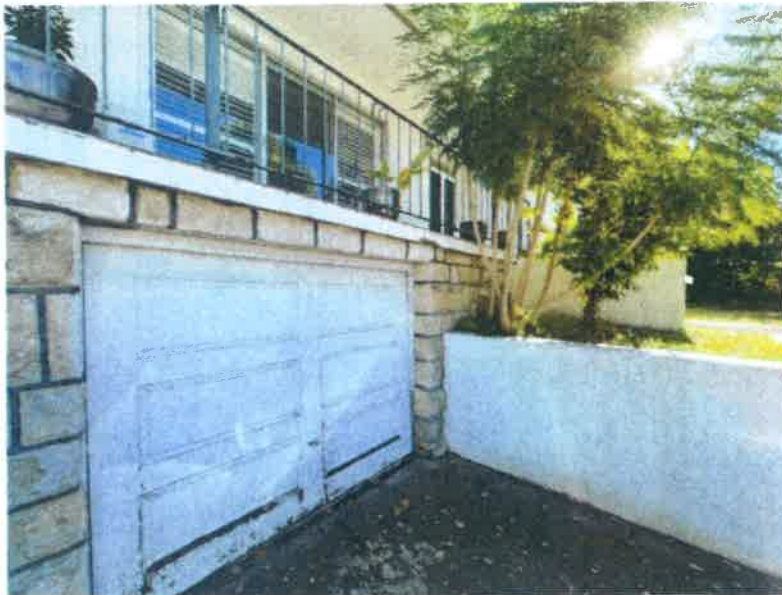
Restoration to floor boards along hallway/ New Garage door at front of residence/Repair to the verandah

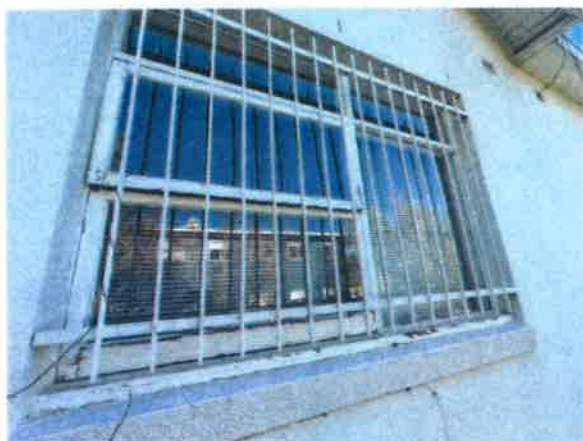
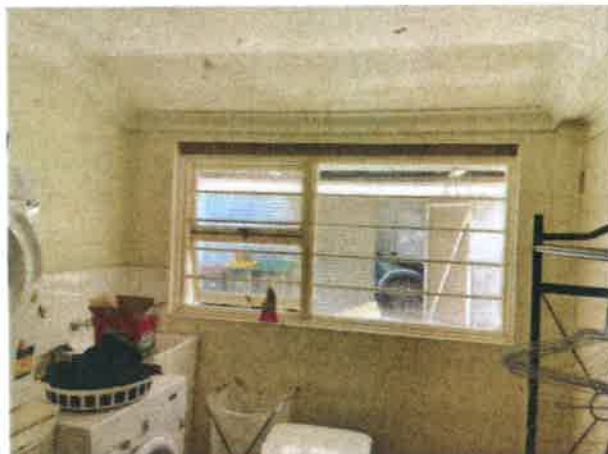
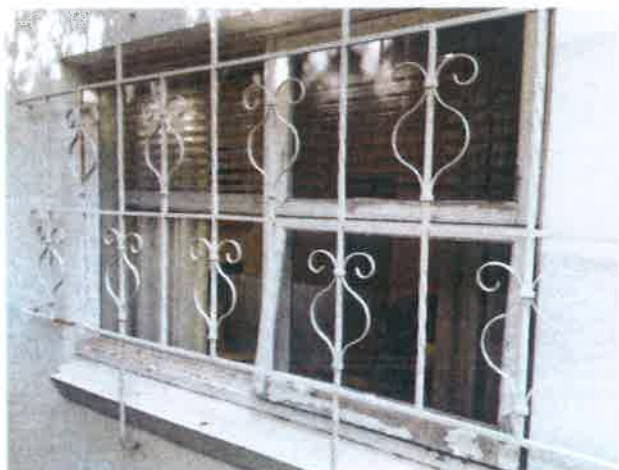
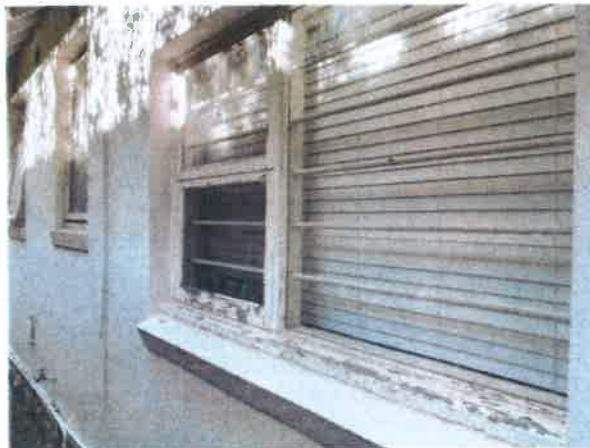
Painting
